**Report on the Structural Condition of the
Remaining Built Fabric,
Of Kilbarron Castle, Creevy,
Co. Donegal¹**

¹ Prepared by:
Joe Gorman, Chartered Structural Engineer, BE, CEng, MIEI.
J.A.Gorman, Consulting Engineers & Project Managers,
Unit 1, Block B,
Forest Park,
Mullingar,
Co. Westmeath.

Kilbarron Castle

ASSESSMENT OF VISIBLE REMAINING BUILT FABRIC

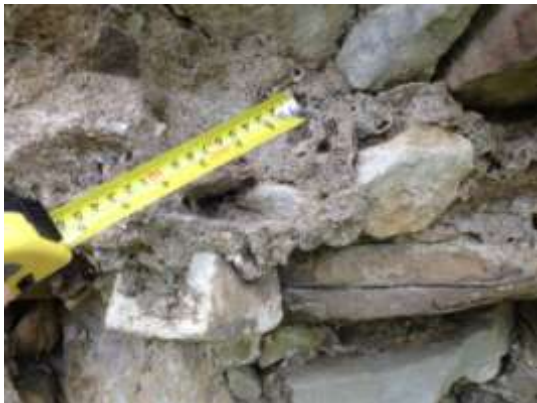
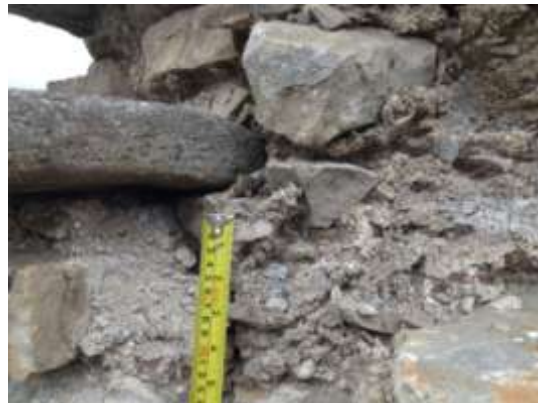
Views of mortar in the wall core areas

Mortar close to where sample B was taken.

Mortar in area of sample A

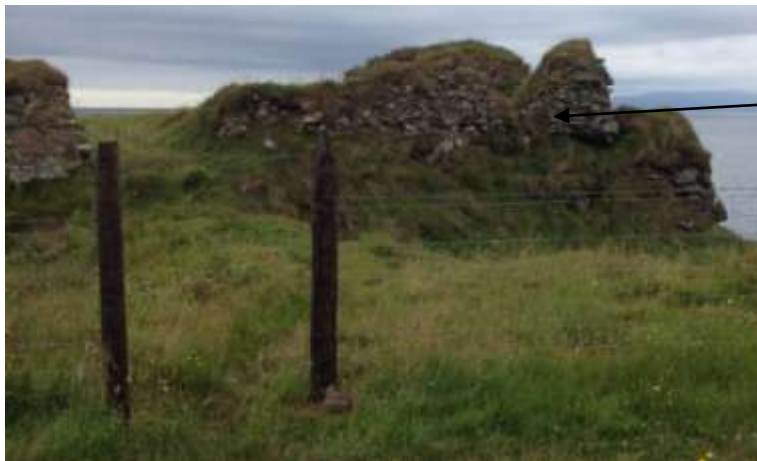
East wall of gate-house keep has largely collapsed and remaining section has lost all its facing stone on the outside leaving the core exposed.

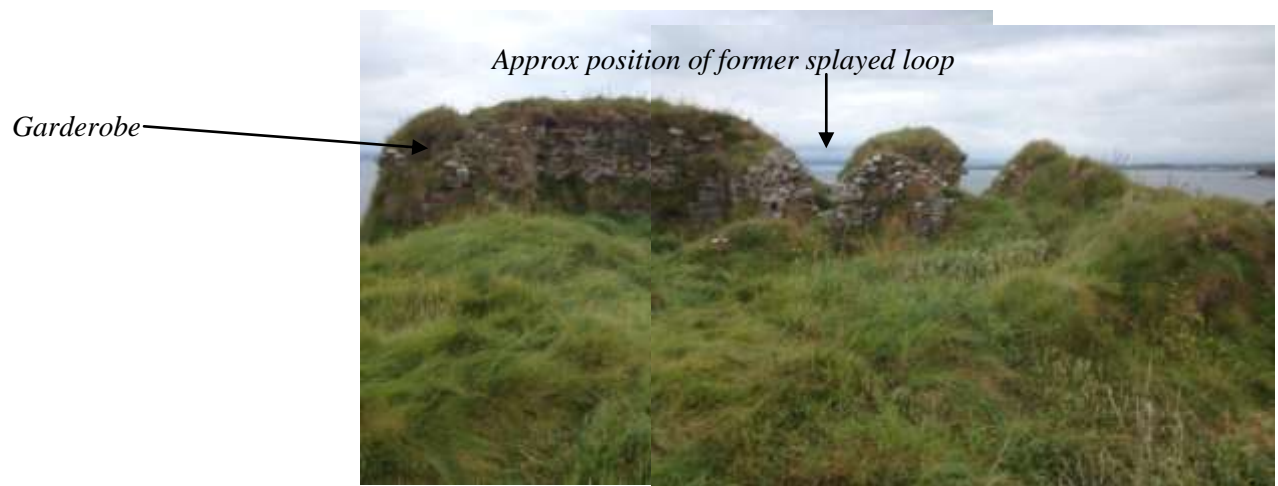
View of remains of gate-house keep from the south with the garderobe on the left. View is of inside face of external north wall with the remains of E-W internal wall in the foreground.

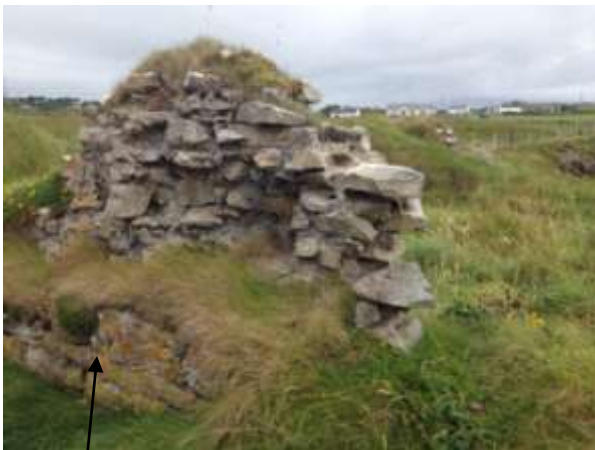
Facing stone on lower part of north face of internal wall running E-W

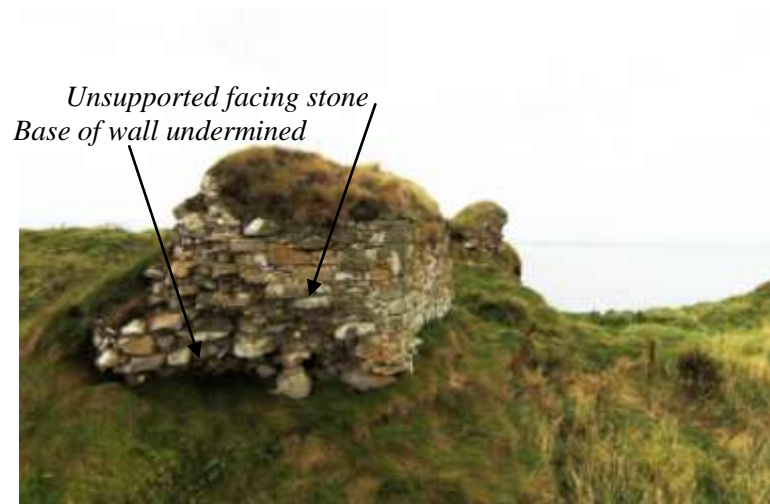
View 4

The condition of the south end of this wall section is the most problematic. Here the base of the wall has been undermined, extensive areas of the wall core are exposed and there are areas of unsupported facing stone (*view 4*). It may be that facing stones at the base of the wall were robbed out to build nearby field walls and that this, possible damage from animals, and weathering and washing out of mortar all contributed to damage the wall. There is mortar loss from facing stone to a depth of 30mm or more on this and all parts of the building complex. The degree of instability of this section of masonry is commented on in the Engineer's report.

- b. Spalling masonry at end of wall will require rough racking and masonry repairs to stabilise.
- 4.5 Curtain Wall:
- a. Significant Undermining issue and excessively cantilevering section of masonry – stability concerns, high priority. Locally undermined section to be temporarily propped and new masonry installed to reduce overhang to a safe dimension on a new local foundation

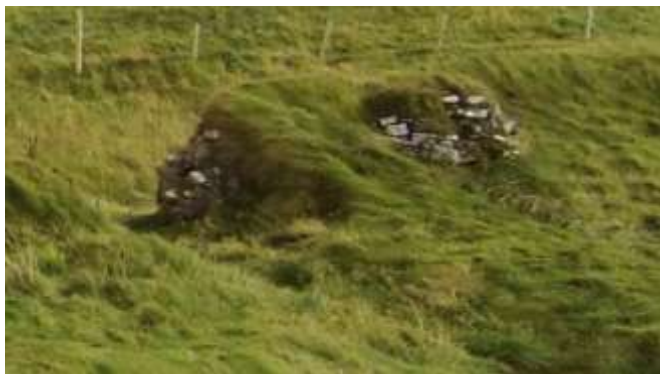
View 1

end where the wall turned and continued in a south westerly direction. At the other end was the external corner where the wall joined the wall running east-west parallel to the wall of the keep. This east-west section of wall is collapsed and appears as a grass covered mound (*view 5*). The upstanding curtain wall retains its facing stone on the east face (*view 3*) but the core is exposed at both ends (*views 4 and 2*) and the back (west face) is largely grass covered and the visible stone appears partially displaced and unstable (*view 1*).

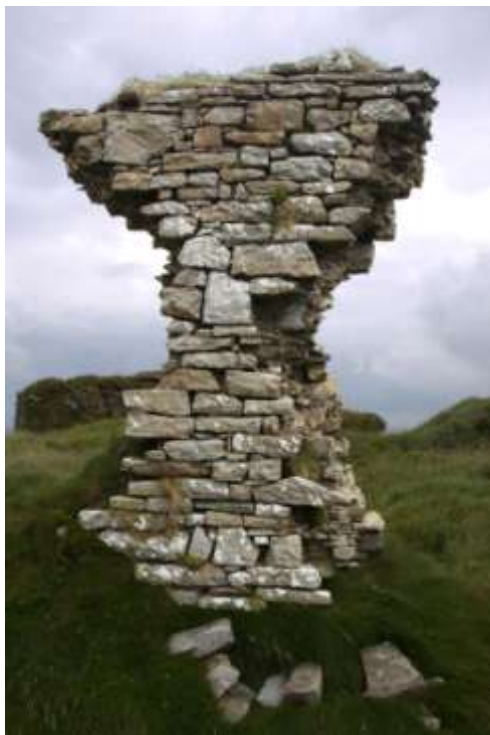
View 8

The north section of wall appears also to be in imminent danger. Facing stone is mostly in place though missing in part at the critical narrowest section (*view 8*). See Engineer's comments. There is grass and small plant growth on the exposed wall head. Both sections of wall are affected by mortar loss from between facing stones, similar to that on all other parts of the ruin complex.

- c. Masonry/rough racking repairs will be required to locally spalled sections of infill masonry in centre of walls.
- 4.3 Building B –
- a. North Wall – Concerns regarding instability and excessive cantilever/leaning section of wall remaining.
Investigate stabilisation by drilling and grouting in Stainless Steel rods into remaining masonry or possibly concrete shell encasement to ends of remaining masonry walls with bolt through clamping details. Suitability of existing masonry structure to be assessed by specialist contractors to check if such a repair strategy will be feasible in this case.

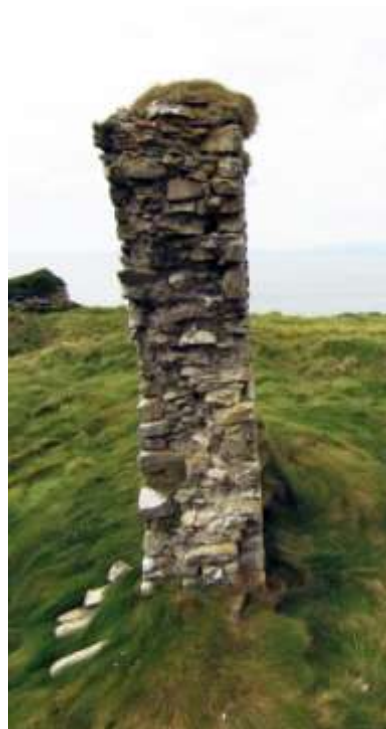
View 7

The remaining section of the north wall of Building B (*views 5-8*) is the most dramatic element of the ruined building complex as seen from the land. It consists of a piece of masonry a little over 1m thick and about 4.5m high, roughly shaped like an hourglass, the upper section seeming to defy gravity as it overhangs the section below. The facing stone is extant on both wall faces but there are no stone features (corners, lintels) remaining. See Fergus Cleary Report for c.1910 photograph by William Arthur Green showing remains of a window in the south wall of this building, now collapsed. Much

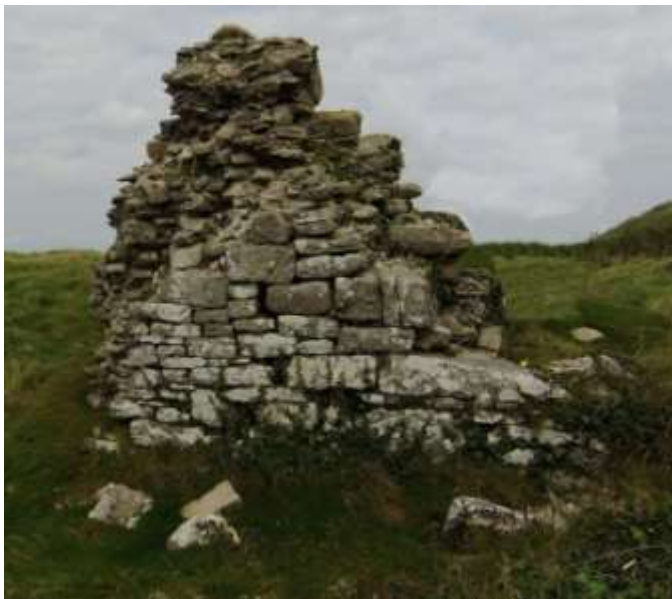
View 4

Both sections of walling forming the remains of this building are in a precarious state. The south piece of wall consists only, on its upper half, of the inner facing stones with a little of the core material attached (*views 1 and 3*). This upper part of the wall is in danger of collapse in the short term. Only the base of the exposed core areas is affected by vegetation growth to any extent.

- b. South Wall - Local undermining issues noted on facing stone outer layer facing North. Rebuilding of masonry is required to stabilise façade stone. New repair masonry to be recessed to differentiate from original facing stones.

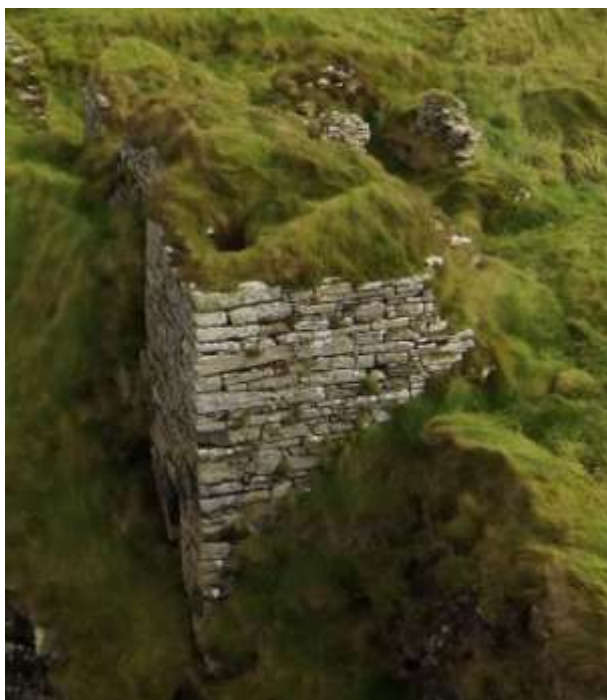
View 2

The outer face of the remains of the east wall of the keep (*view 6*) has lost all its facing stone while the inner face is almost entirely grass covered. The outer face appears particularly vulnerable with the base of the wall fallen away leaving core work overhanging above. The extent of exposed core makes further collapse likely. The middle part of the wall has already collapsed entirely.

- b. Eroding soil/missing mortar visible in parts of the East elevation wall to be raked out and replaced with repair mortar/masonry to stabilise this section of the keep East elevation wall.

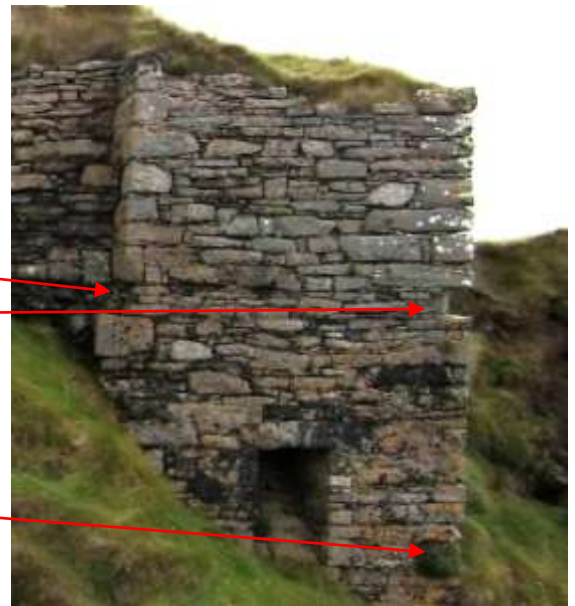
Some facing stones at the top of the wall appear loose and may be in danger of being dislodged by vegetation growth. Isolated loss of quoin stones increase the vulnerability of the wall.

Missing quoin stone?

Missing quoin stone

Missing quoin stone replaced by vegetation?
