Ecological Report on Kilbarron Church - County Donegal

June 2021

Brief description of the proposed works.

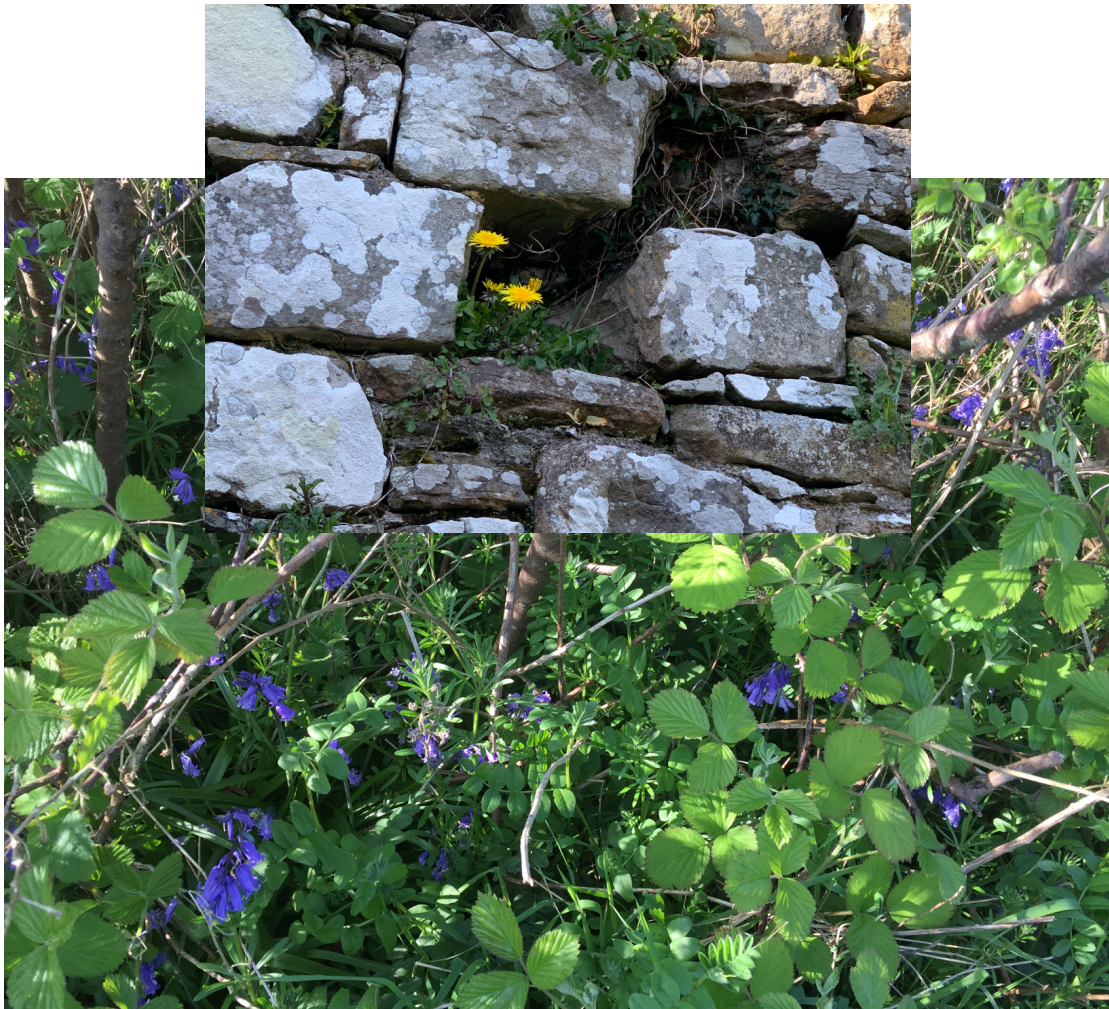
Bluebells growing in the children's graveyard.

The children's graveyard was first recorded on the OSI map circa 1905 so may be 19th Century.

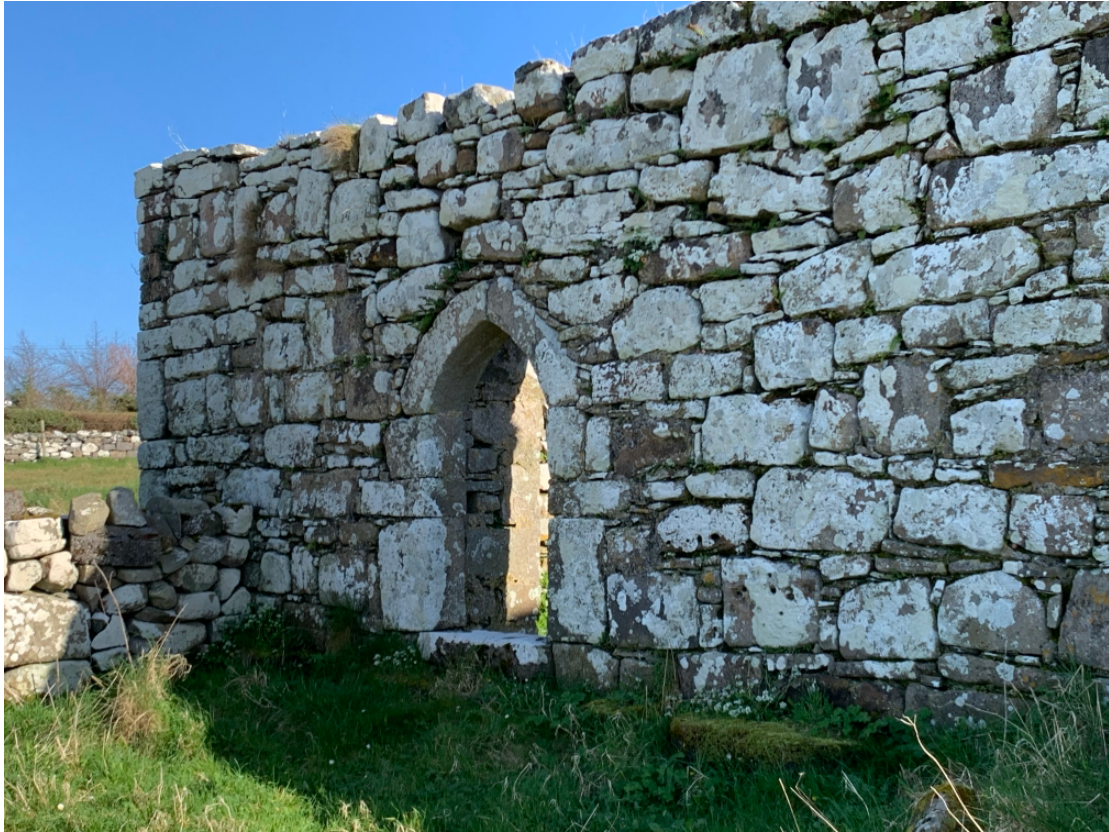
The church is a small unroofed rectangular stone building with a window aperture on the west gable end. At the east end there is a mound of rubble which was probably the alter. There is also a niche in the wall next to the 'alter'. The east facing gable wall is no longer complete. There are sockets on the walls at the western end of the church. Socket in the west end of the internal north wall.

The current church is medieval in origin although it is almost certainly on

the site of a much older church. The church is accessed via a dressed stone door on the south side. There is another similar door on the north side that leads into an area bounded by a dry stone wall.

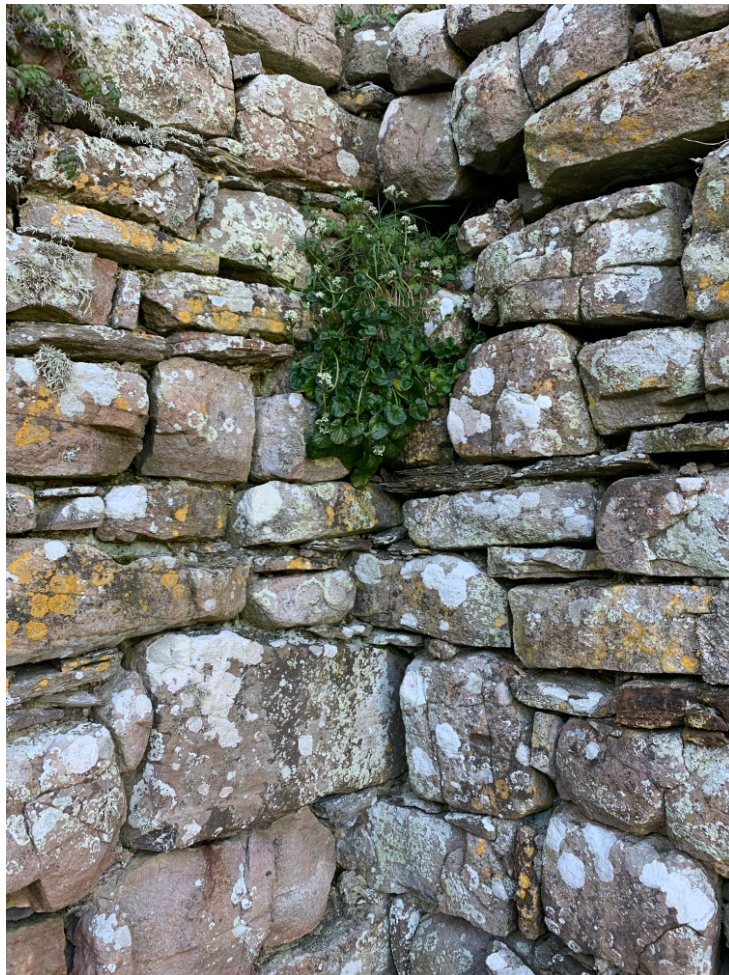
Common scurvy-grass growing on a wall inside the church.

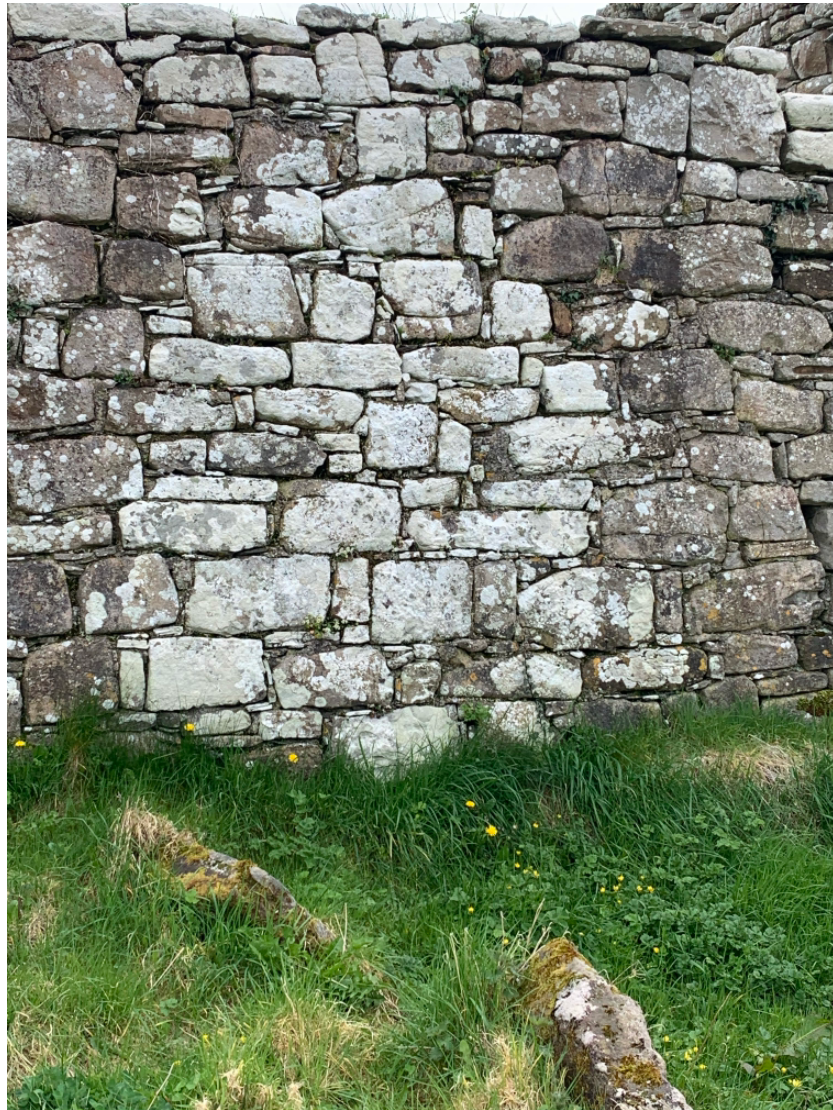
On the northern external wall there are fan shapes in the lichen where ivy has been removed in the past

4. The removal of the ivy on the church walls under the instruction of an archaeologist so that the walls aren't damaged further.
5. A working party in the late spring to hand weed plants like stinging nettles, brambles and thistles so they don't choke out other species.

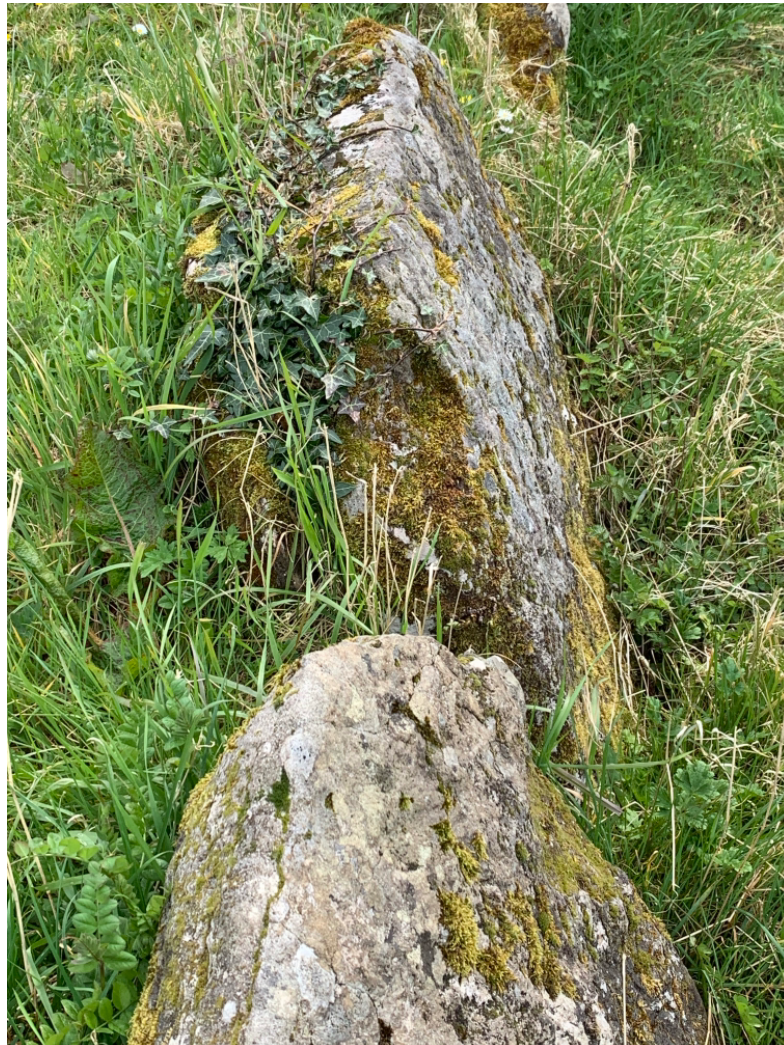
This is a rectangular area, attached to the church and bounded on one side by the church and the other 3 sides by a low dry stone wall.

The area is bisected by a line of rough cut gravestone like stones. There is no inscriptions on the stones.

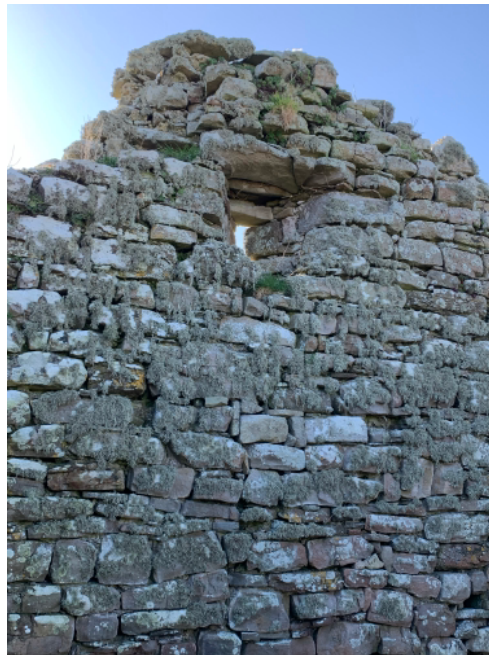
Community of lichen growing on the west internal wall.

Although an expert in lichens would be needed to identify the species of lichen I think it is unlikely that there are any species rare to the area. The church is built of local stone. Often it is in graveyards where non local stone has been used that species rare to the area are found. The species of lichen tends to depend on the substrate.

However where the walls are not shaded or covered by ivy, the stones are covered by a mass of lichen which gives the stone walls much of their character. Lichen is slow growing and there is little that can be done to help colonisation. The use of yogurt or sour milk does not seem to increased the rate of colonisation although it was long thought to do so. However with such a thriving local colony of lichens, and weathered rocks providing the perfect substrate I would hope that recolonisation would quickly occur. The use of natural products in any restoration or consolidation of the walls - such as lime mortar - will not inhibit the recolonisation of the wall with lichen.

6. The use of a lime mortar in any consolidation of the church walls. This is lichen friendly and should encourage the recolonisation of the walls by lichen.
