**Report on the Structural Condition of the
Remaining Built Fabric,
Of Kilbarron Castle, Creevy,
Co. Donegal¹**

¹ Prepared by:
Joe Gorman, Chartered Structural Engineer, BE, CEng, MIEI.
J.A.Gorman, Consulting Engineers & Project Managers,
Unit 1, Block B,
Forest Park,
Mullingar,
Co. Westmeath.

Kilbarron Castle

ASSESSMENT OF VISIBLE REMAINING BUILT FABRIC

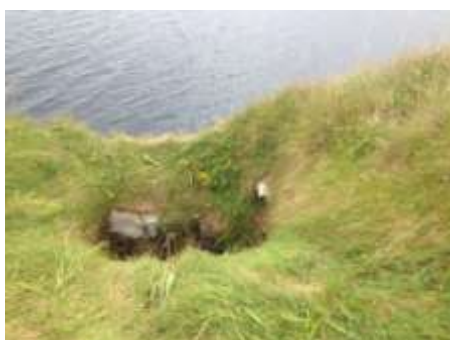
Garderobe shaft from above.

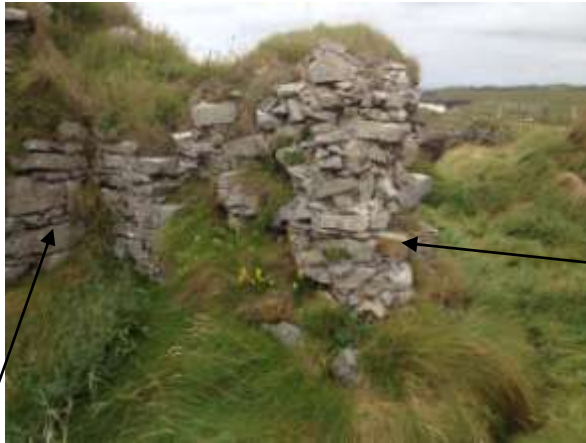
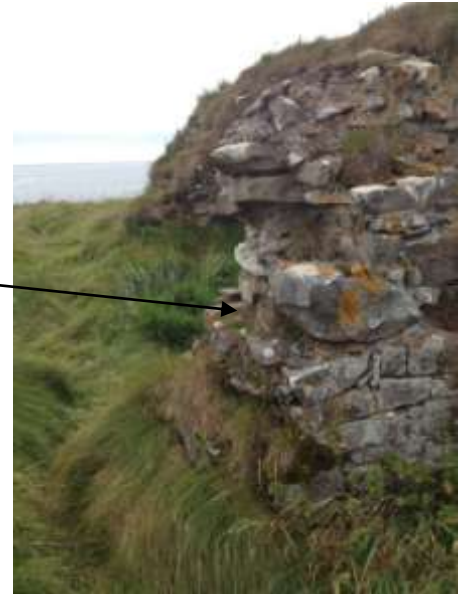
*Some facing stone remaining in internal NE corner of NW room of keep.
Location of drawbar hole serving doorway in W wall of NE room referred to by Lacy*

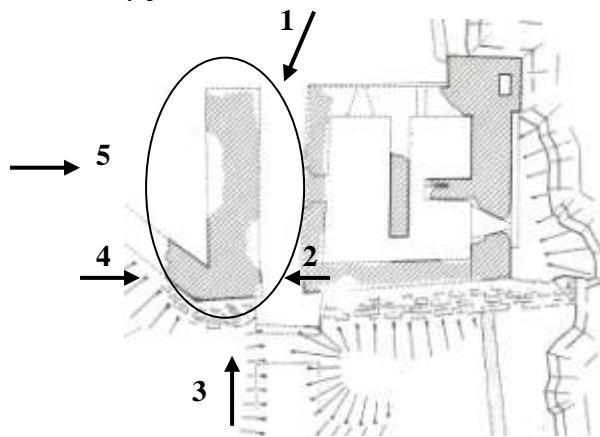
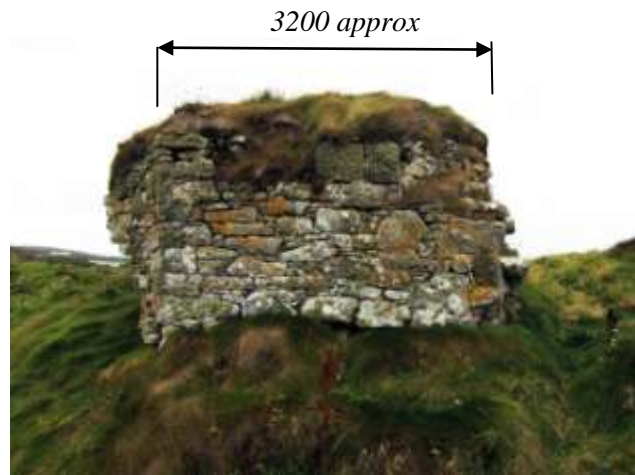
View 3

The condition of the south end of this wall section is the most problematic. Here the base of the wall has been undermined, extensive areas of the wall core are exposed and there are areas of unsupported facing stone (*view 4*). It may be that facing stones at the base of the wall were robbed out to build nearby field walls and that this, possible damage from animals, and weathering and washing out of mortar all contributed to damage the wall. There is mortar loss from facing stone to a depth of 30mm or more on this and all parts of the building complex. The degree of instability of this section of masonry is commented on in the Engineer's report.

- b. Spalling masonry at end of wall will require rough racking and masonry repairs to stabilise.
- 4.5 Curtain Wall:
- a. Significant Undermining issue and excessively cantilevering section of masonry – stability concerns, high priority. Locally undermined section to be temporarily propped and new masonry installed to reduce overhang to a safe dimension on a new local foundation

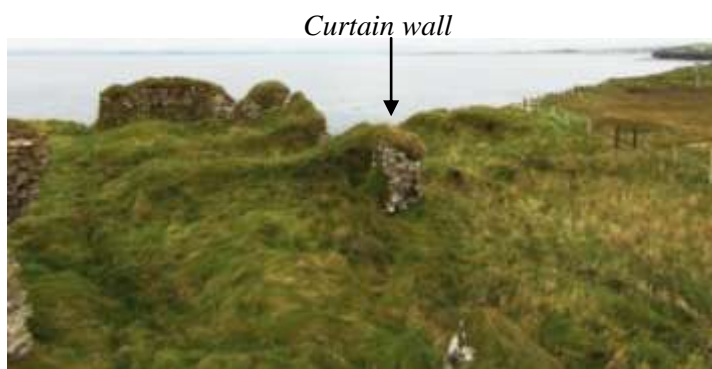
View 5 (distant view)

end where the wall turned and continued in a south westerly direction. At the other end was the external corner where the wall joined the wall running east-west parallel to the wall of the keep. This east-west section of wall is collapsed and appears as a grass covered mound (*view 5*). The upstanding curtain wall retains its facing stone on the east face (*view 3*) but the core is exposed at both ends (*views 4 and 2*) and the back (west face) is largely grass covered and the visible stone appears partially displaced and unstable (*view 1*).

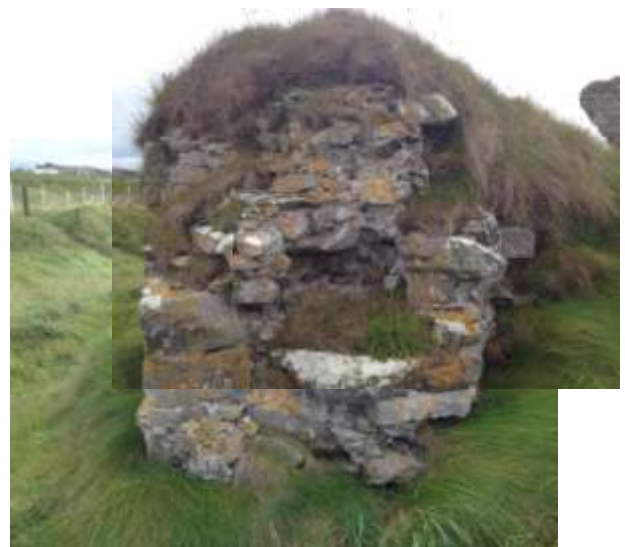
View 2

Only a short section of the curtain wall remains upstanding. The wall is about 1500mm thick by about 3.2m long and about 2m high. There is another sizeable piece intact but fallen over a short distance to the south. The upstanding piece includes an external corner of somewhat more than 90degrees on one

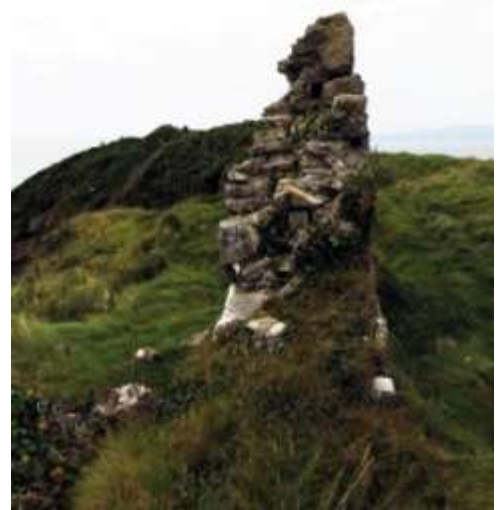
View 3

Both sections of walling forming the remains of this building are in a precarious state. The south piece of wall consists only, on its upper half, of the inner facing stones with a little of the core material attached (*views 1 and 3*). This upper part of the wall is in danger of collapse in the short term. Only the base of the exposed core areas is affected by vegetation growth to any extent.

- b. South Wall - Local undermining issues noted on facing stone outer layer facing North. Rebuilding of masonry is required to stabilise façade stone. New repair masonry to be recessed to differentiate from original facing stones.

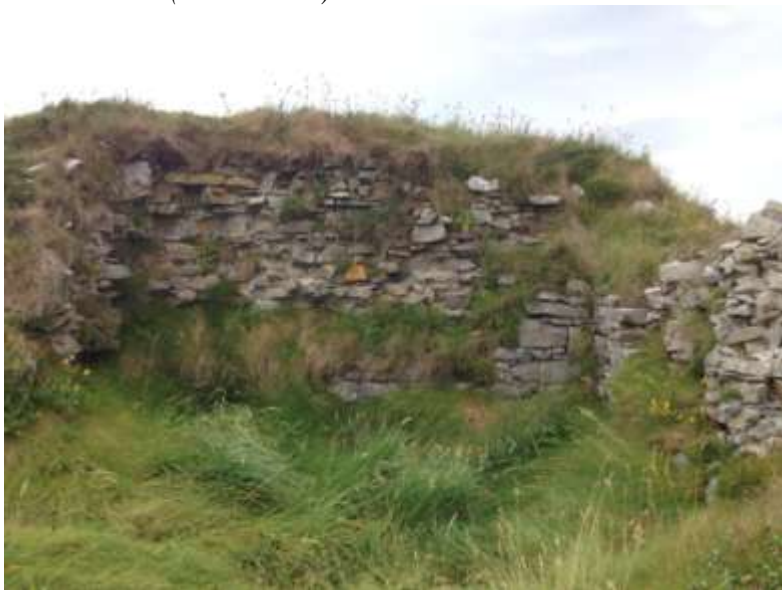
View 8

The north section of wall appears also to be in imminent danger. Facing stone is mostly in place though missing in part at the critical narrowest section (*view 8*). See Engineer's comments. There is grass and small plant growth on the exposed wall head. Both sections of wall are affected by mortar loss from between facing stones, similar to that on all other parts of the ruin complex.

- c. Masonry/rough racking repairs will be required to locally spalled sections of infill masonry in centre of walls.
- 4.3 Building B –
- a. North Wall – Concerns regarding instability and excessive cantilever/leaning section of wall remaining.
Investigate stabilisation by drilling and grouting in Stainless Steel rods into remaining masonry or possibly concrete shell encasement to ends of remaining masonry walls with bolt through clamping details. Suitability of existing masonry structure to be assessed by specialist contractors to check if such a repair strategy will be feasible in this case.

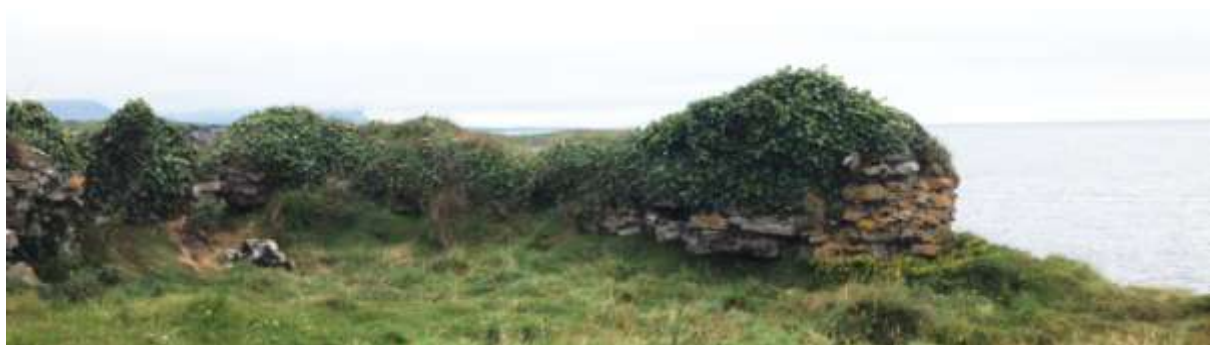
View 6

The remains of Building C are scant, only sufficient remaining to outline the south and west walls. Two short sections reach about 2m in height, one in the centre of the south wall (*views 5 and 6*), the other at the north end of the west wall (*views 1 and 2*). Both these areas retain some facing stone. Otherwise the remains of the walls are low and extensively ivy covered. There appears to have been a considerable amount of robbing of stone from these walls and it seems to have been a favoured spot for building open air fires. As elsewhere, stone has been lost at the base of the walls leaving vulnerable overhanging areas above.

The condition of these walls is poor, much being largely collapsed but the detailed condition obscured by ivy. It is likely that the ivy roots have extensively penetrated the core of the walls and are destabilising the remains. Small remaining sections of facing stone are close to collapse due to loss of stone below.

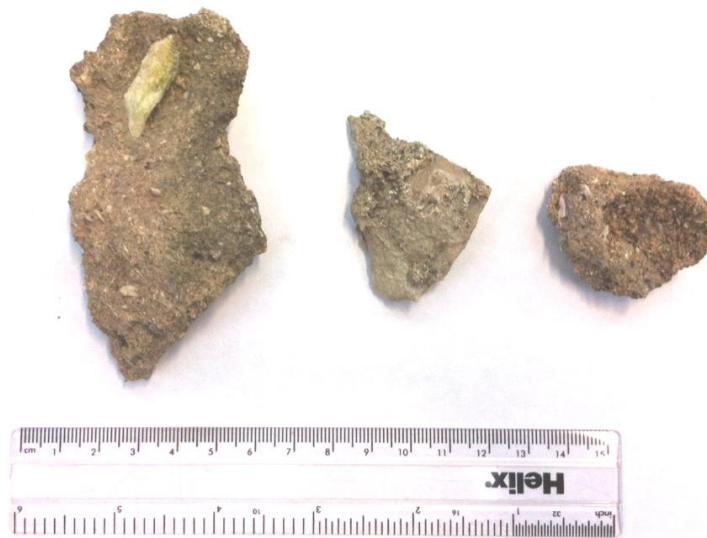
Selection of mortar sample pieces as supplied. On the left is a piece of mortar with a substantial shell embedded. In the middle is a piece of masonry debris (sandstone) with some mortar attached. On the right is a piece of mortar eroded into a conical shape.

Large, +35mm in size, stone (sandstone) inclusions are bedded into the mortar sample. These are unlikely to be part of the original mix but added during building to use up masonry debris and spalls from stone shaping. The addition of these stones can have a positive effect on the overall performance of the mortar giving it more stability and durability.

Shell, up to 17mm in size, is also a significant component of the mortar mix. The inclusion of shells, crushed and whole, can have a strengthening contribution to a traditional mortar. They can have a mildly pozzolanic effect on the mortar but also their lamellar nature can be quite robust and durable. The source of these shells, which make up c. 1/5 of the overall aggregate mix is likely to be from sand drawn from the shore nearby and used in the mortar. Shells (or even sea sand comprised of a high proportion of calcareous material) can also be burned in a kiln to make the lime binder. This was very common in coastal Ireland and may be the provenance of the lime binder but the shells in this sample did not go through a kiln.

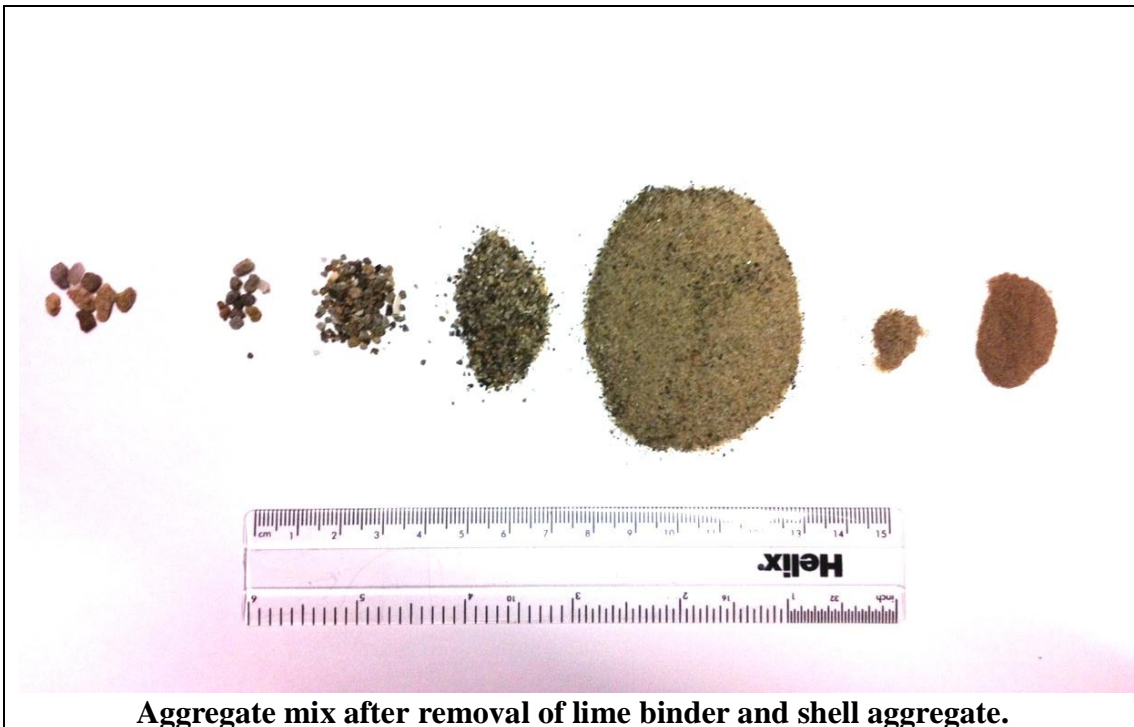
The overall colour of the mortar is reflected in the sand particle colours which range from purple through to orange, buff and cream. There are flakes of mica and particles of granite giving the mortar a general cream colour with a sparkly lustre.

Aggregate mix after removal of lime binder and shell aggregate.
