# **Ecological Report on Kilbarron Castle, County Donegal**

# November 2014

#### Brief description of the proposed works.

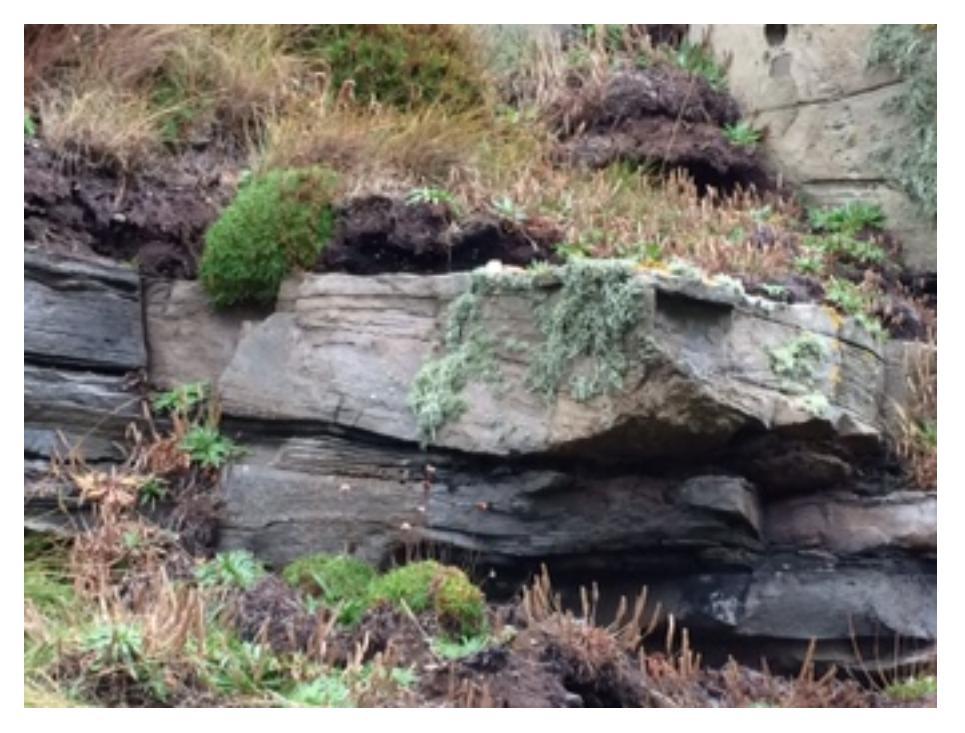
The cliffs below the castle. Cushions of thrift and lichens.

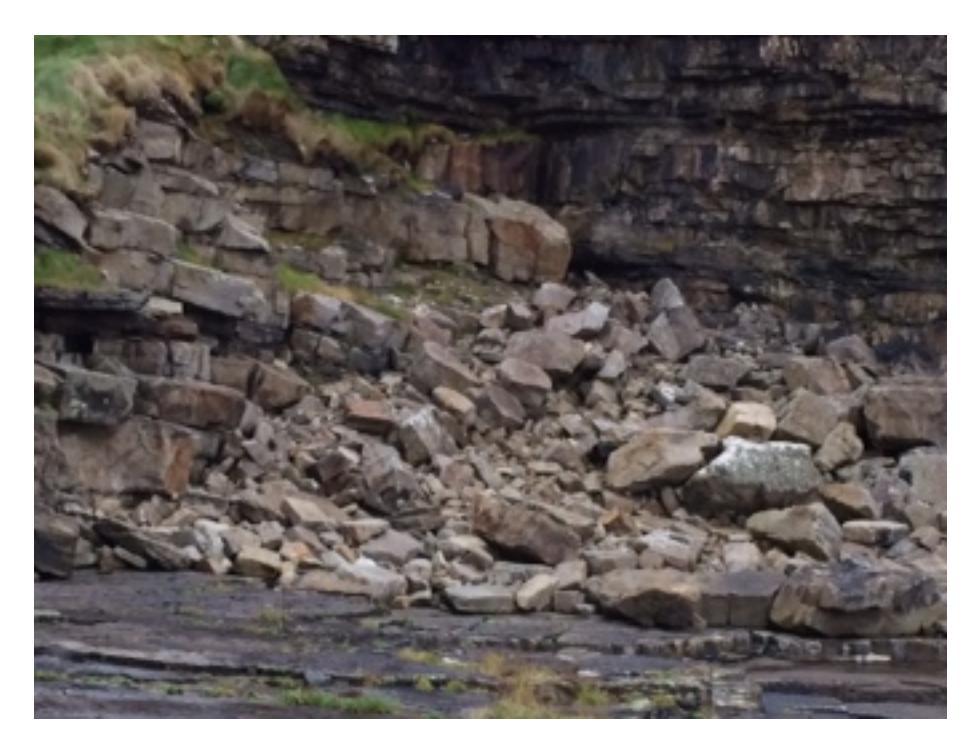
Recent rockfall below the castle walls

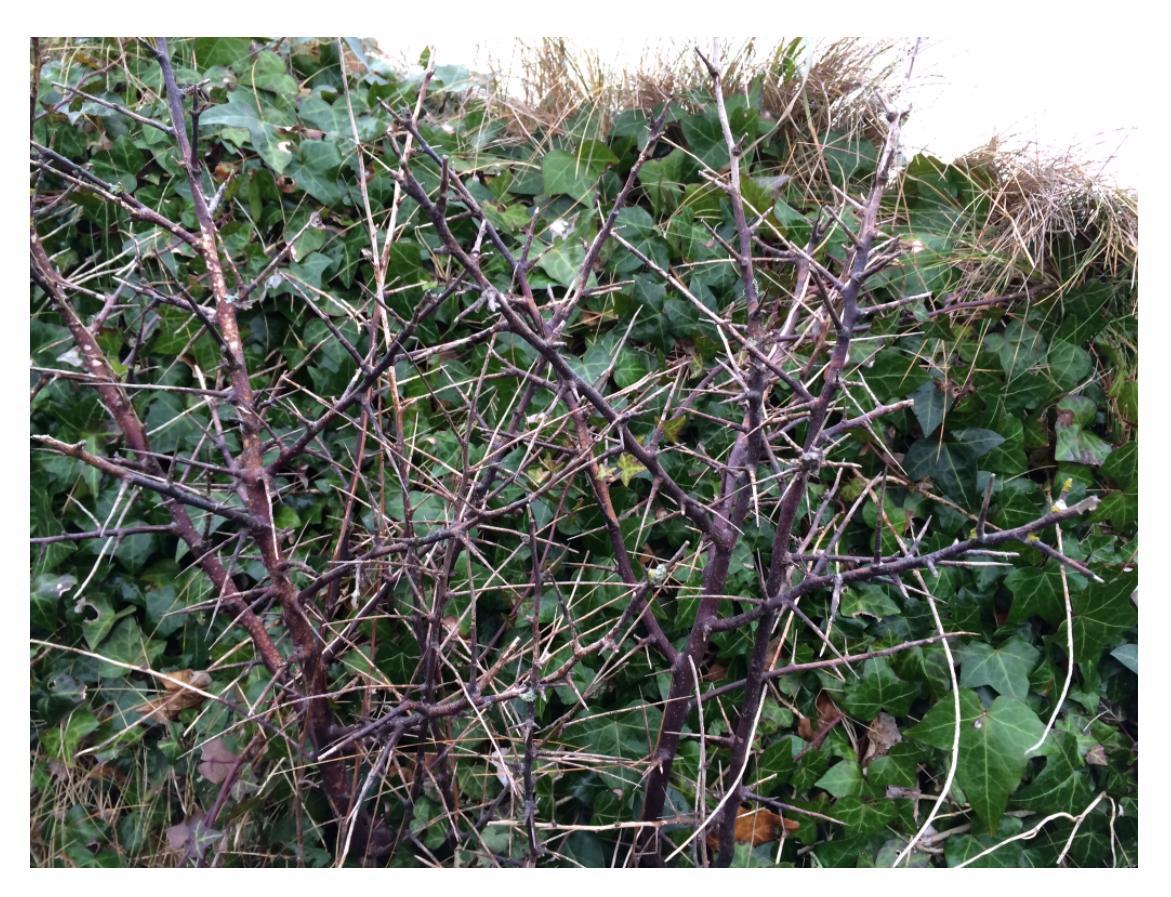
Hedera helix - the walls are largely ivy covered. Asplenium marinum - sea spleenwort in crevices underneath the walls. Prunus spinosa - stunted blackthorn on the sea. Galium velum- ladies bedstraw at the base of the walls.

lvy covered walls and blackthorn.

- 2. The removal of the ivy on the outer seaward walls ( if this is not felt to destroy the character of the castle). The prevention of further colonisation by ivy on the inner walls. The ivy should be cut at the base and left to die back to avoid any damage to the walls. The removal of ivy will encourage the growth of lichens.

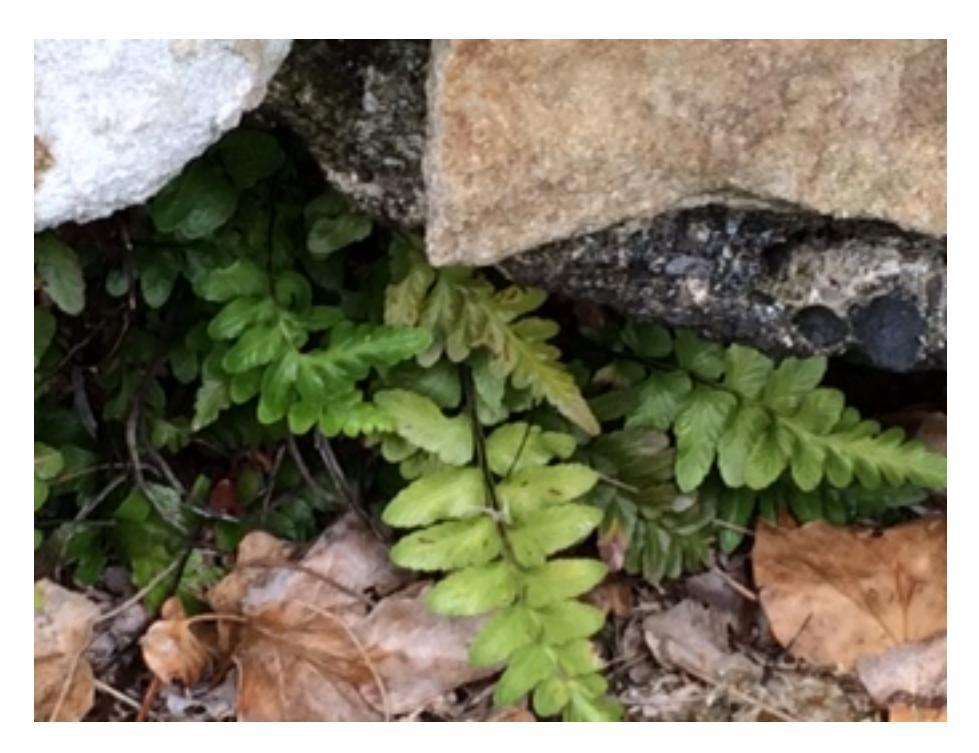
Sea spleenwort in the crevices under the wal

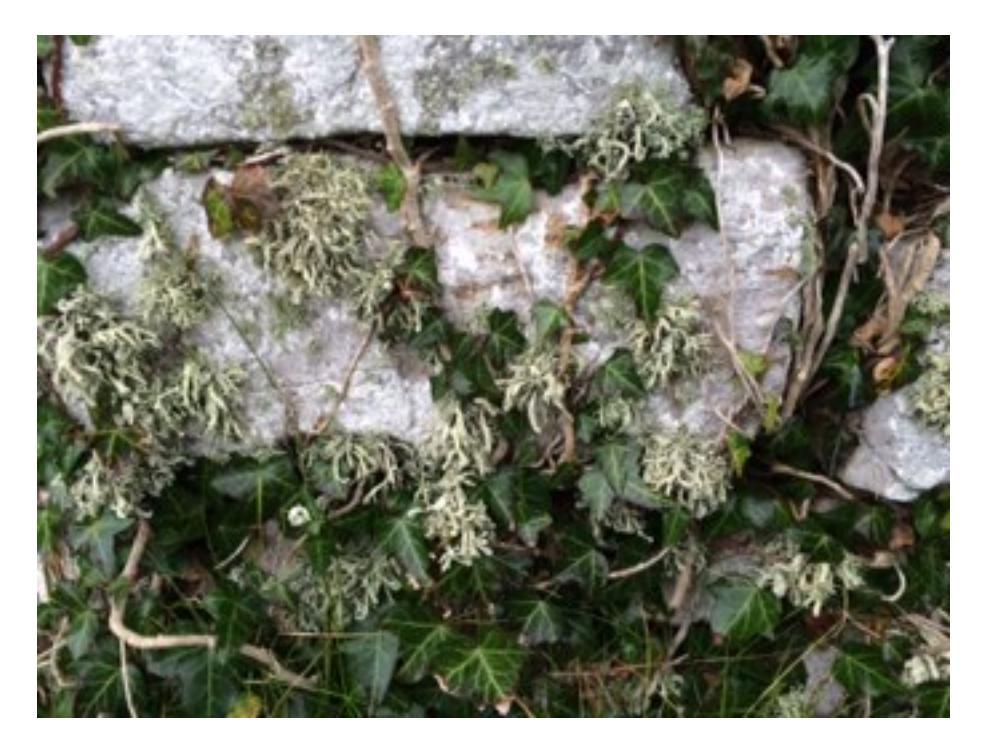
Colonisation of ivy (Hedera helix) smothering the lichen community.

Where the walls are covered by ivy, lichens will be unable to grow. Ivy in itself tends to be destructive of old walls. If it is controlled it needs to be cut at the roots so it will die back naturally. Pulling it away from the wall will lead to increased damage of the walls.

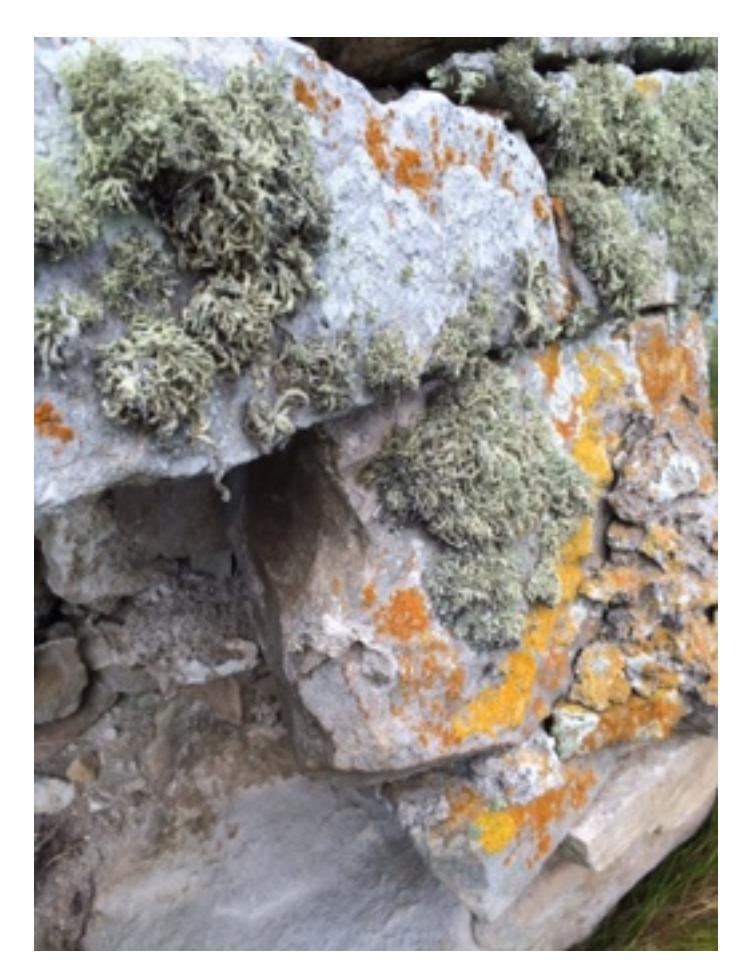
Community of lichen

However where the walls are not shaded or covered by ivy, the stones are covered by a mass of lichen which gives the stone walls much of their character. Lichen is slow growing and there is little that can be done to help colonisation. The use of yogurt or sour milk does not seem to increased the rate of colonisation although it was long thought to do so. However with such a thriving local colony of lichens, and weathered rocks providing the perfect substrate I would hope that recolonisation would quickly occur. The use of natural products in any restoration or consolidation of the walls - such as lime mortar - will not inhibit the recolonisation of the wall with lichen.

- 3. A working party in the spring to hand weed plants like stinging nettles, brambles and thistles so they don't choke out other species.
- 4. The use of a lime mortar in any consolidation of the castle walls. This is lichen friendly and should encourage the recolonisation of the walls by lichen.
